**BR-23-09: Tazewell County, Virginia
US 19/460 (TRAIL OF LONESOME PINE ROAD / GOV.
GEORGE C. PEERY HIGHWAY) FROM LIMESTONE
ROAD TO POUNDING MILL BRANCH ROAD**

Complete Project Pipeline Study Report

Draft Submittal: July 2024

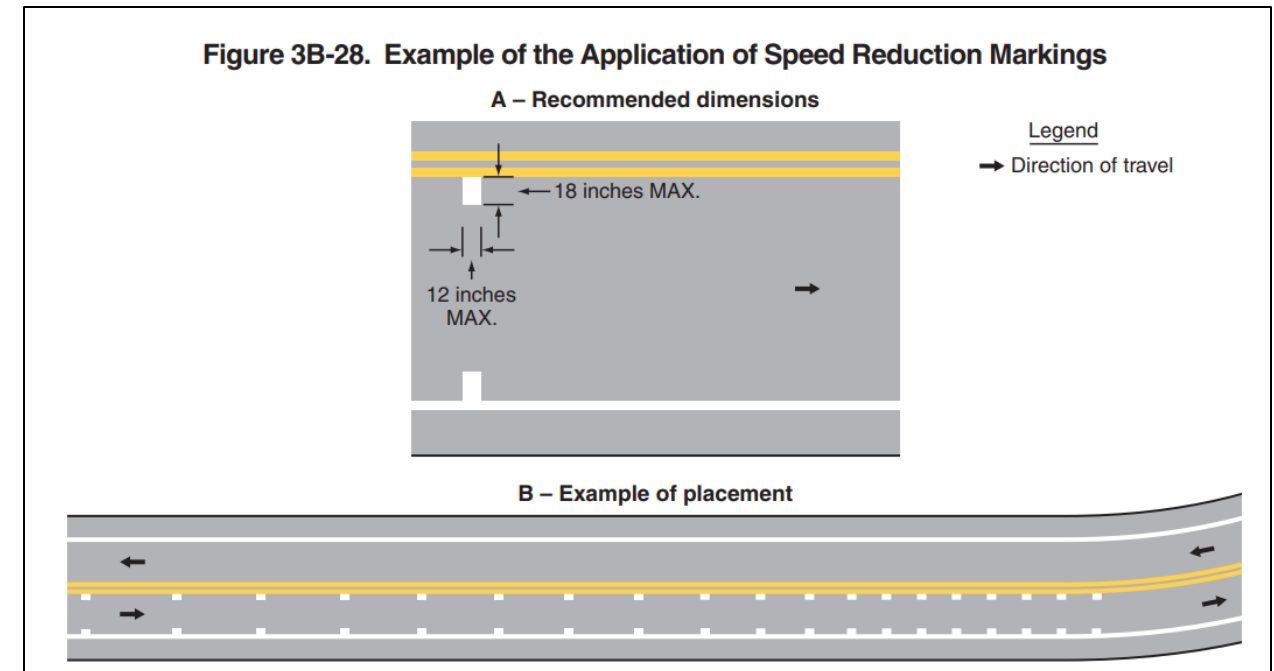
Figure 18: Speed Reduction Pavement Markings, Source: Manual of Uniform Traffic Control Devices (FHWA)

The study team considered multiple alternatives to encourage slower operating speeds. One alternative consisted of narrowing the lane widths; however, the lane widths are already 11 feet, which is the minimum for this roadway. For this reason, narrowing the lane widths was not considered further. The study team also considered transverse rumble strips but did not advance this alternative due to the residential surrounding land uses. Pavement marking treatments and additional signing were also assessed to encourage slower operating speeds. Pavement marking treatments included pavement markings such as optical speed bars and in-lane curve warnings as seen in **Figure 18** and **Figure 19**. Signing alternatives included chevrons, curve warning signs, and advisory speed limit plaques.

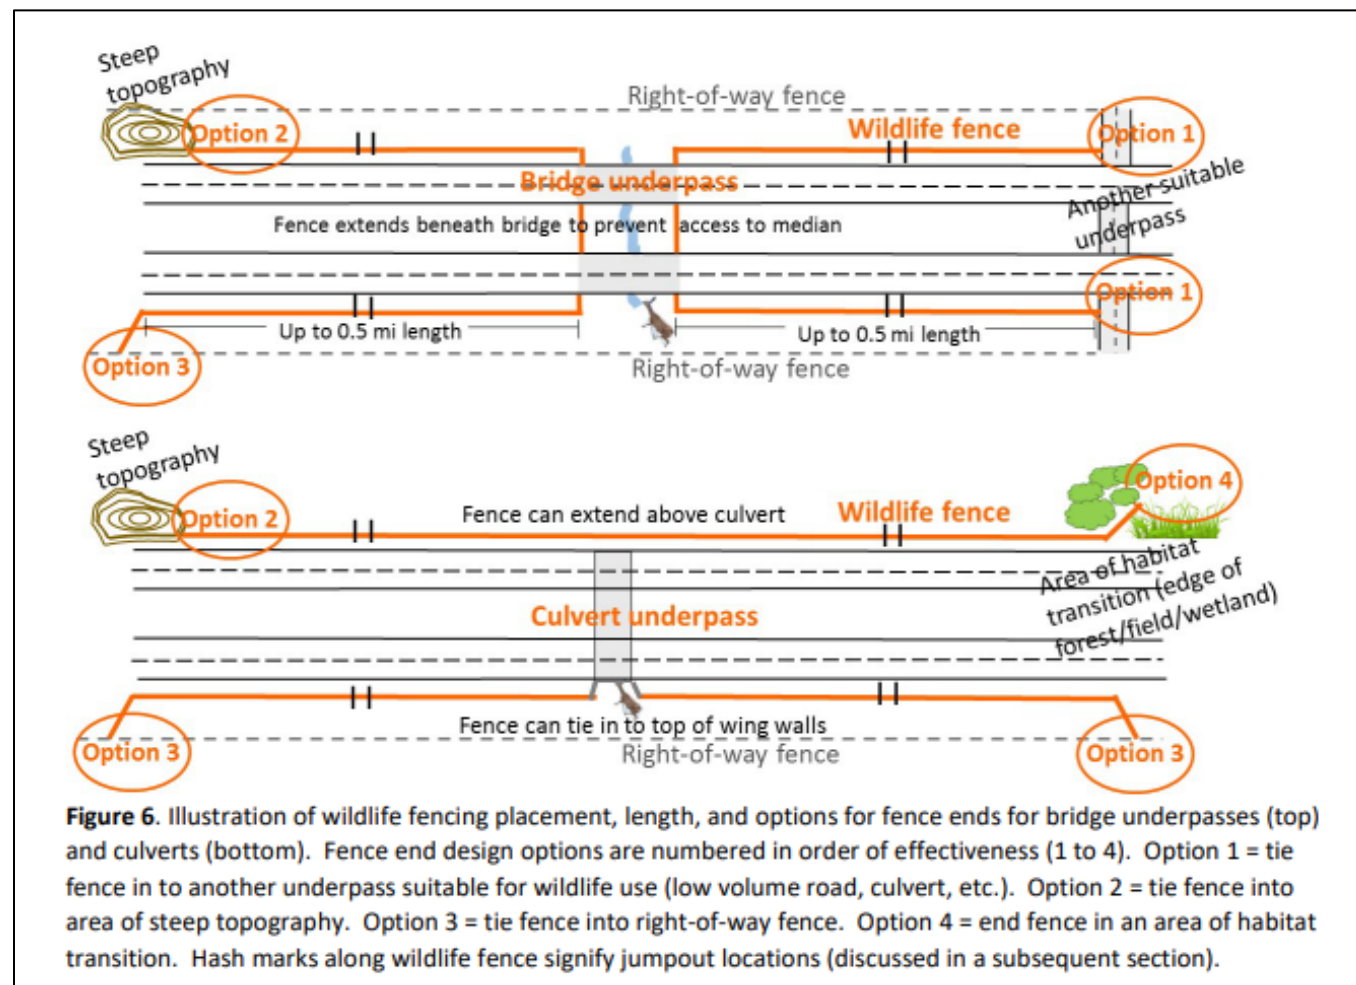
Figure 21: Wildlife Fencing and Crossing Options

For animal crashes, an early alternative considered was a grade separated wildlife crossing utilizing an existing underpass, animal fencing, and dynamic animal warning signs. **Figure 21** shows some of the fencing and animal crossing options initially considered; these were subsequently discarded due to concerns with cost, railroad coordination, and pushing the animal crossing issue to the edge of the animal fencing. The hotspots for animal crashes (**Figure 22**) were considered further for other alternative development and screening.

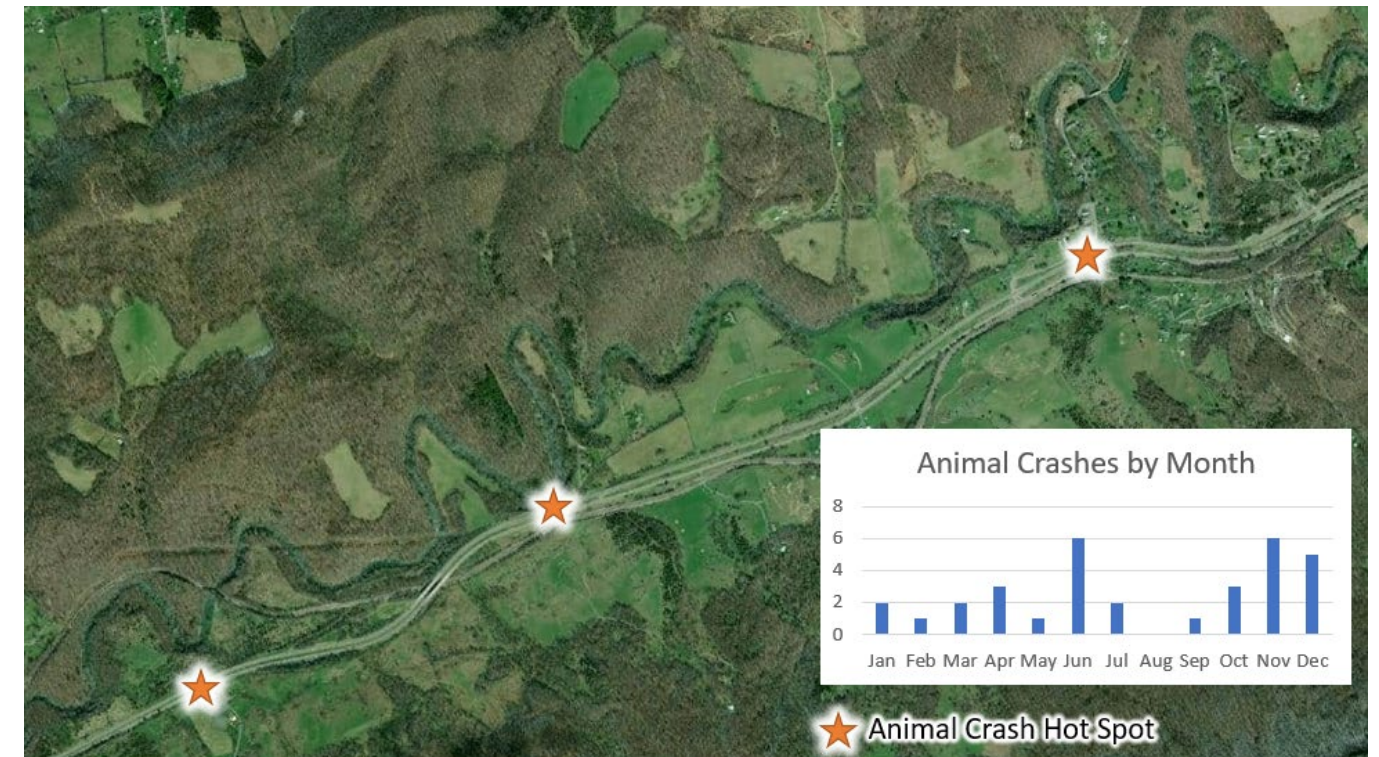
Figure 22: Animal Crash Data

To address the clusters of animal crashes shown in **Figure 22**, animal warning signs were considered. General guidance is that deer or other large animal crossing signs should be installed if there were at least 5 reported large animal/vehicle crashes in the span of one year and if the posted speed limit is 45 MPH or greater. The study corridor meets the speed limit requirements for this. While this segment of the corridor does not meet the crash threshold, it is possible that the number of animal crashes is currently underreported. Sources indicate that large animal crashes may be underreported by 5-10 times.

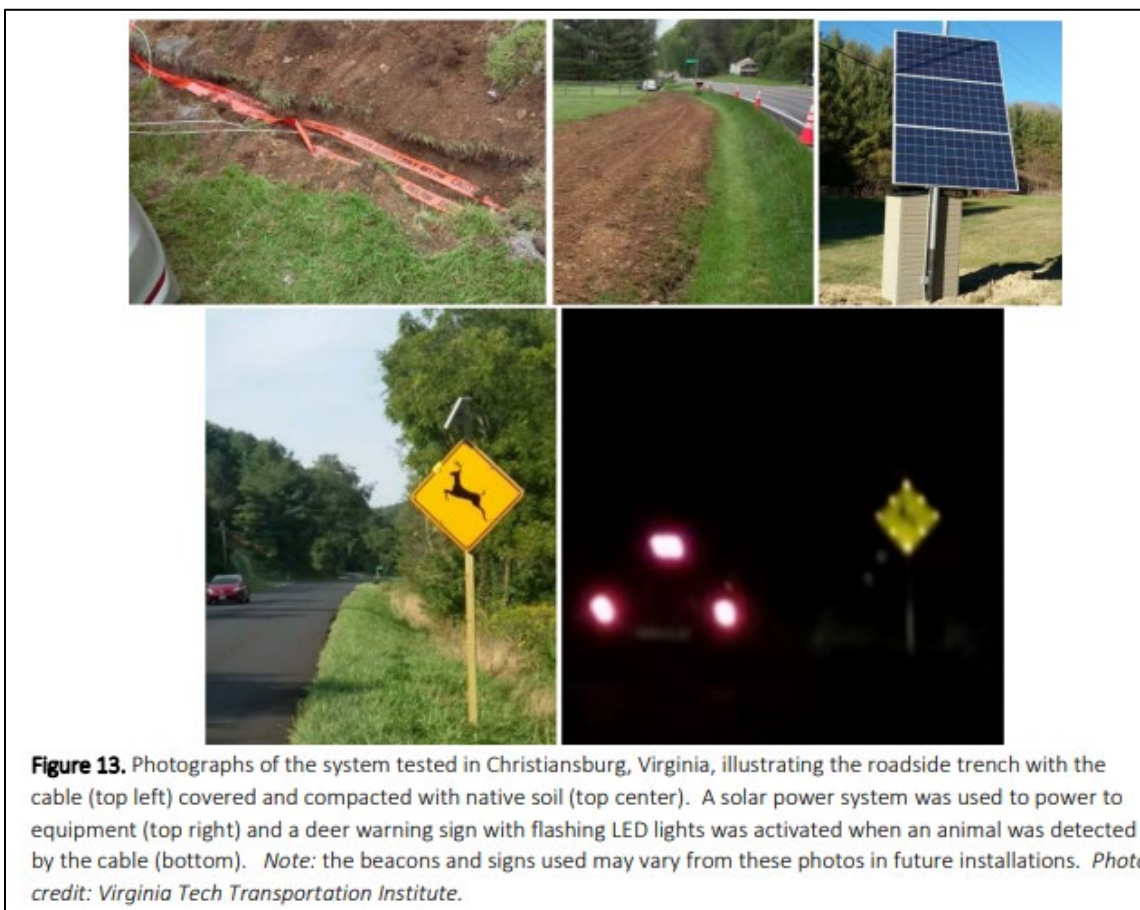
Figure 24: Animal Detection Warning System, Source: "Large Animal Crash Countermeasures in Virginia", Virginia Transportation Research Council, April 2022.

The crash data showed that there were higher concentrations of animal crashes in June, November and December, and a concentration in nighttime. Given these clear peaks of activity, seasonal advisory signs on changeable message signs were considered that could be activated during the historical peak crash periods. Examples of the seasonal advisory signs on changeable message signs can be seen in **Figure 23**. An animal detection warning system was another alternative considered. As of now, there are only pilots of this system deployed, and Virginia studies have found these pilots successful at detecting animals. No evaluation has been done about their effect on crash reduction. To install these warning systems, the sites need solar or power access, fiber/communication connection, more than 15 feet of right-of-way outside of the pavement, and 12 to 18 feet of flat terrain. **Figure 24** presents more information on an animal detection warning system.
