Study Purpose, Goals, and Objectives

To analyze the operational and safety issues identified on Centerville Road and Route 60, with a focus on providing enhanced transit access, pedestrian safety, roadway safety, bike access, pedestrian access, and transportation demand management.

Study Facts

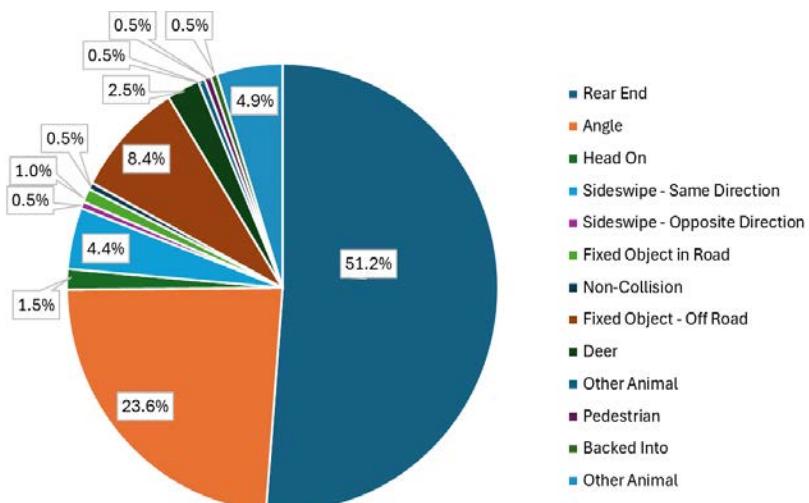
Crash Type

- The total number of crashes in this study area have been increasing in the past five years.
- 203 crashes reported within the study area (2020-2024).
- 75% of injury crashes were rear-end or angle crashes.
- 82% of injury crashes occurred at an intersection (within 250-ft buffer).
- One pedestrian crash and one bicycle crash occurred between 2020-2024 and resulted in one pedestrian fatality and one bicyclist suspected serious injury.

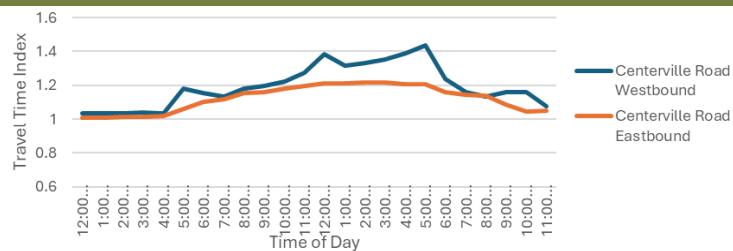
Travel Time Index*

*Travel Time Index (TTI) is the ratio of the travel time during the referenced time period to the travel time during typical conditions. For example, a TTI of 1.5 means a trip takes 50% longer than it would in free-flow conditions.

- Heavy queuing occurred in the left-turn lanes for both the eastbound approaches of the Route 199 West Ramp and Route 199 East Ramp during the AM and PM peak hour periods.
- The signalized intersections of Route 60 and Centerville Road and Centerville Road and Opportunity Way operate at LOS D or worse during the AM peak hour.
- The signalized intersections of Route 60 and Lightfoot Road, Route 60 and Centerville Road, and Centerville Road and Opportunity Way operate at LOS D during the PM peak hour.

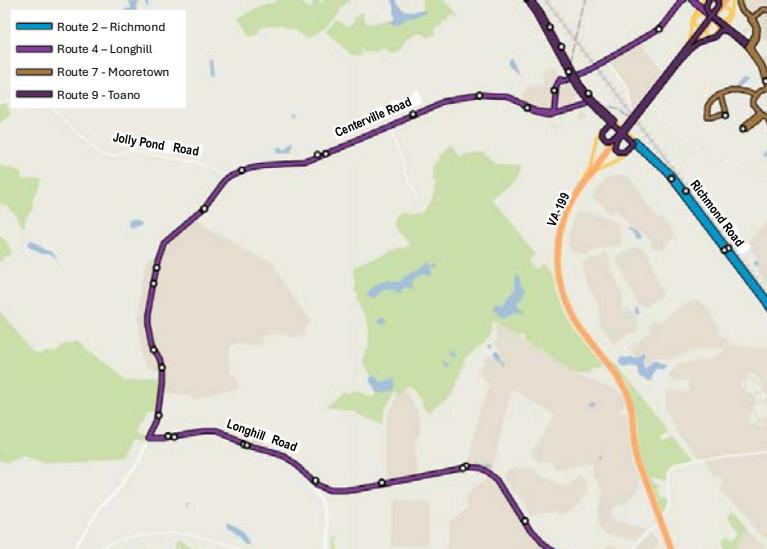
WATA Bus Routes 2, 4, 7, and 9

- Route 60 has Capacity Preservation and Congestion Mitigation VTrans needs due to congestion at Lightfoot Road and the 199 Ramps.
- Pedestrian and Bicycle Access needs for Route 60 and Centerville Road.
- There are three Williamsburg Area Transit Authority (WATA) Routes that service the study area.
