Project Overview | NV-23-06

Arlington Boulevard Interchange

Project Purpose, Goals, & Objectives

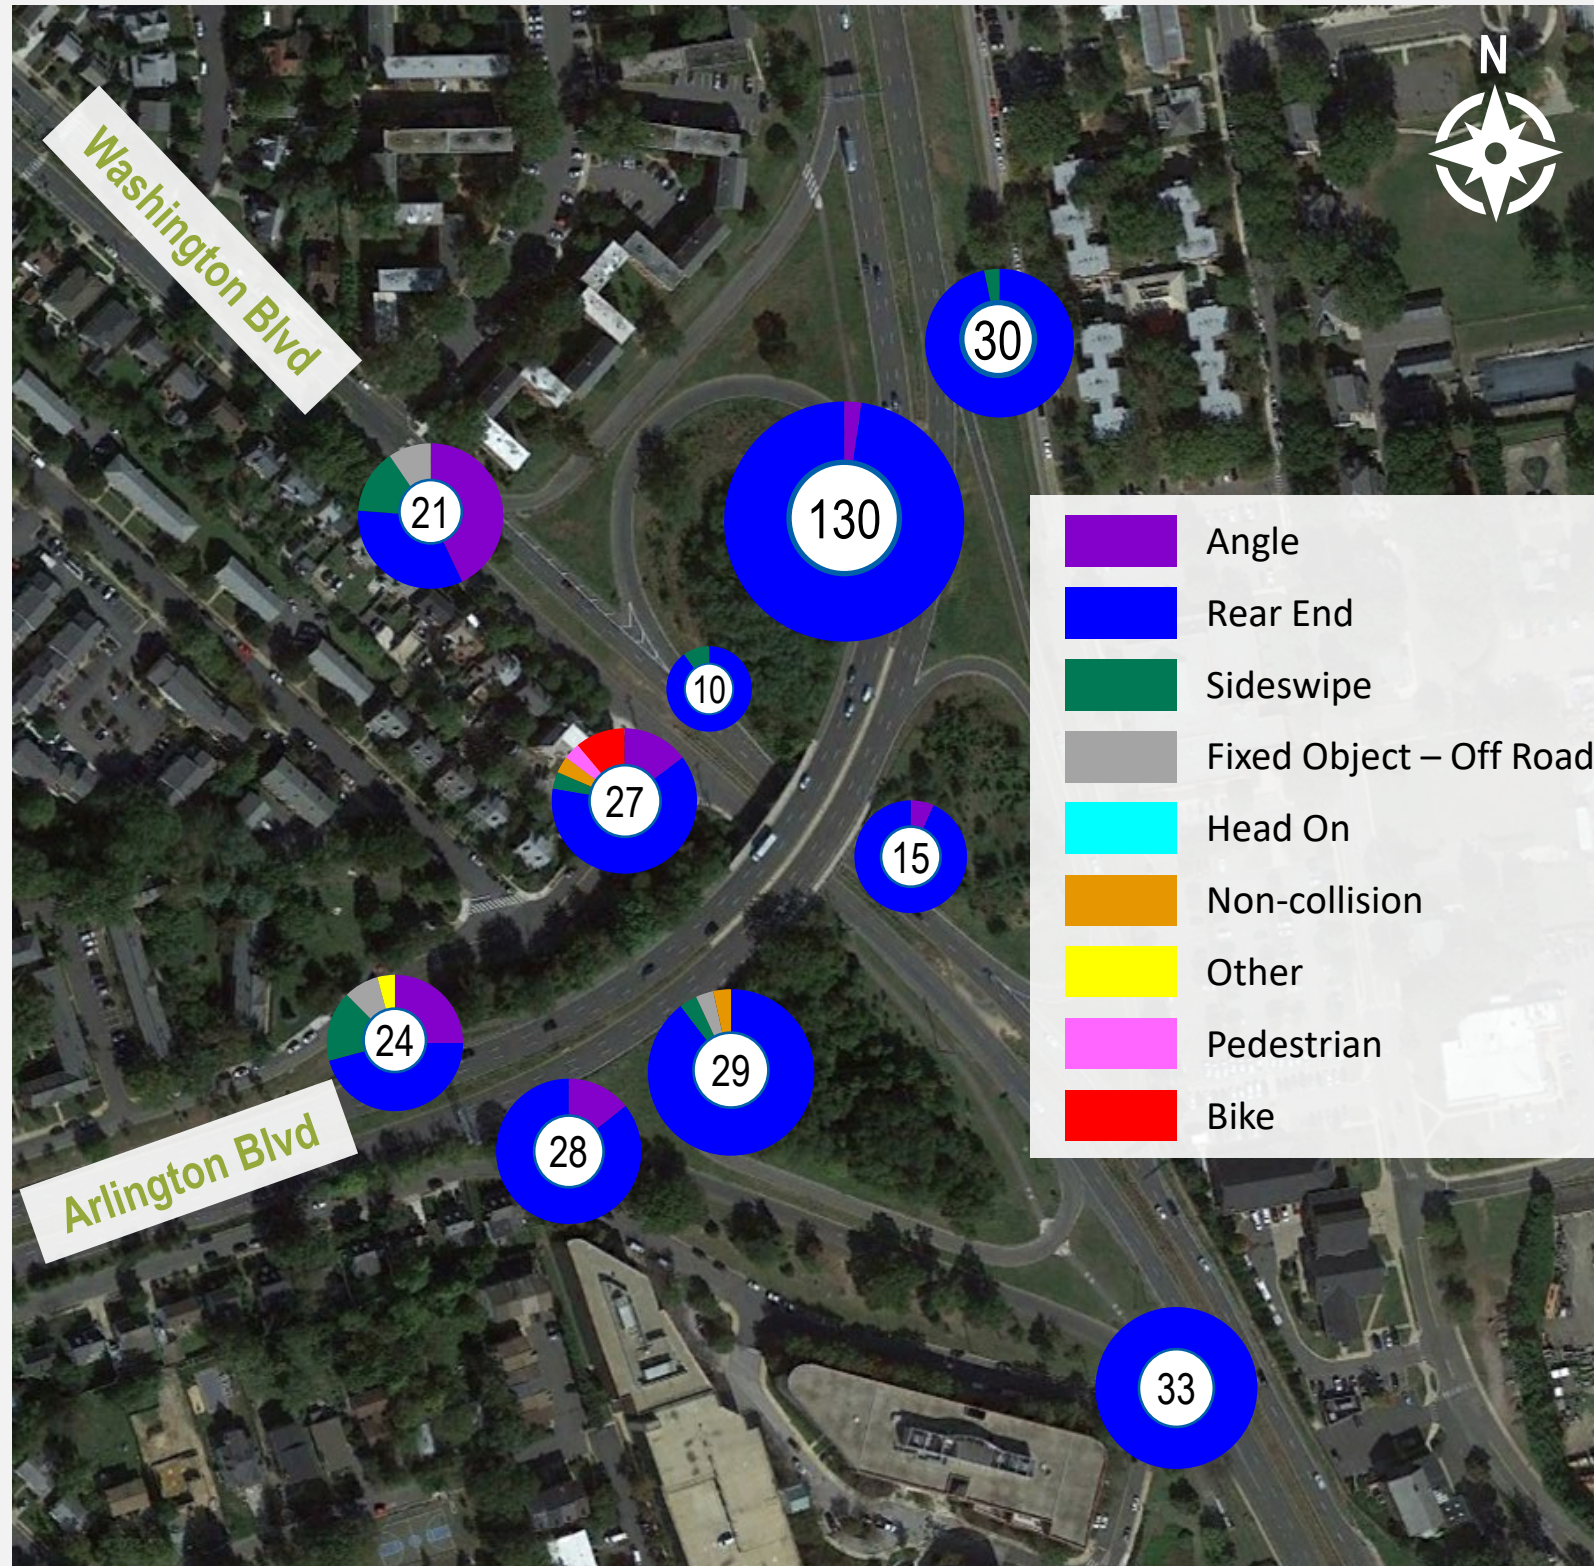
Safety Needs

Needs Identification Summary
