PROJECT PIPELINE NEEDS AND EXISTING CONDITIONS SUMMARY

W Main Street at Pioneer Drive and US 19 Bypass at Regional Park Road
VDOT District: Bristol / Locality: Town of Lebanon

BR-25-04
Sheet 1 of 4

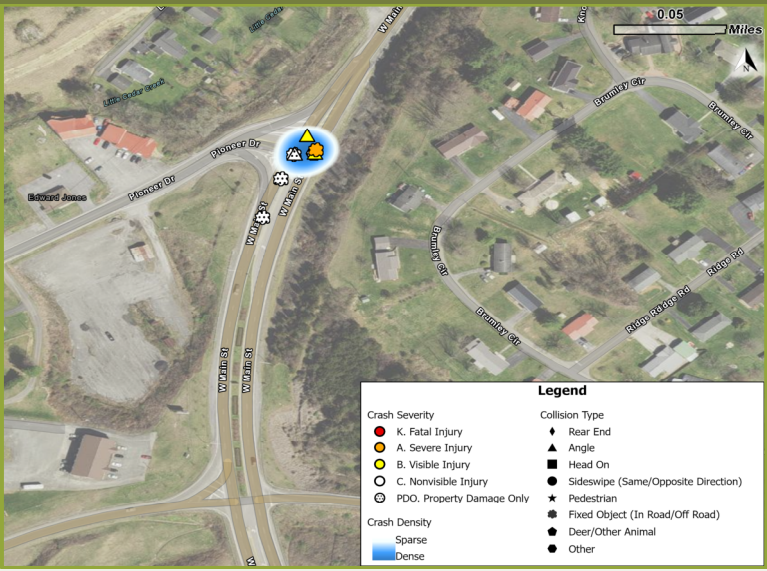
Safety Needs

- Main Street has a medium priority need for Construction District Safety Improvement
- Main Street segment north of Pioneer Drive intersection has a low priority need for Pedestrian Safety Improvement

- 8 crashes occurred at Main Street/Pioneer Drive intersection
- 50% of crashes (4 crashes) were angle collisions involving left turns onto Main Street or Pioneer Drive; 2 of these crashes resulted in a visible injury (B) – both in 2020
- A medical emergency caused the severe injury (A) crash
- 75% of crashes (6 crashes) involved young drivers (15-20), likely due to Lebanon High School nearby (0.7 miles west of study area)

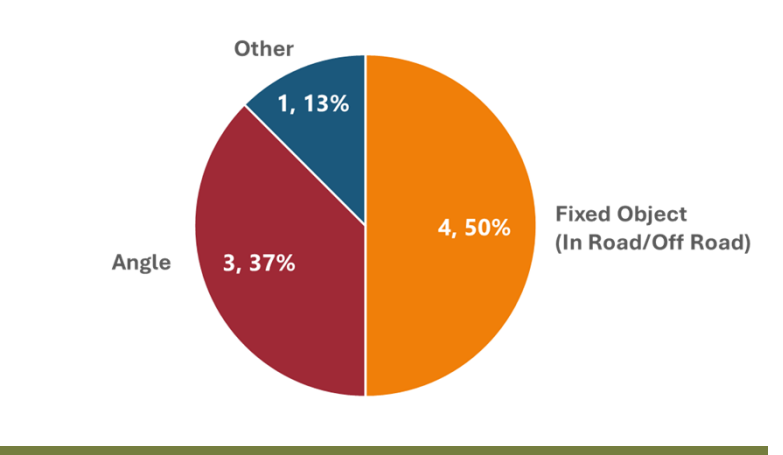
Major Study Intersections	2
Length of Study Area	0.3 mile
Classification	Minor arterial (Main Street) Minor collector (Pioneer Drive)
2023 AADT (Average Annual Daily Traffic)	Main Street: 7,900 Pioneer Drive: 2,400
Speed Limits	Main Street: 35 MPH Pioneer Drive: 35 MPH
Crash Type	8 Crashes (2020 – 2024)

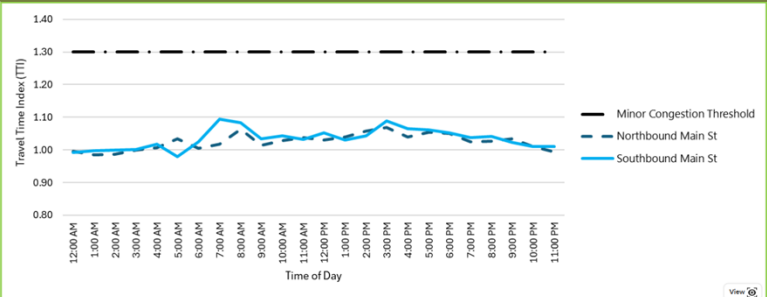
Travel Time Index*

- Network peak hours: 7:45-8:45AM, 3:00-4:00PM, early afternoon peak corresponds with Lebanon High School
- The eastbound left-turn at the Main Street and Pioneer Drive intersection has a poor level of service in the AM (F) and PM (D) peak hours and experiences higher delays with 59.1 seconds and 25.5 seconds, respectively.
 - Peak hour volume (~300) headed southbound on Main Street restricts left turn access on to Pioneer Drive
 - Delay caused for vehicles turning left off Main Street, but smaller volume (~50-100) does not impose significant queue
- Travel time index for the study area is below the minor congestion threshold of 1.3

*Travel Time Index (TTI) is the ratio of the travel time during the referenced time period to the travel time during typical conditions. For example, a TTI of 1.5 means a trip takes 50% longer than it would in free-flow conditions.

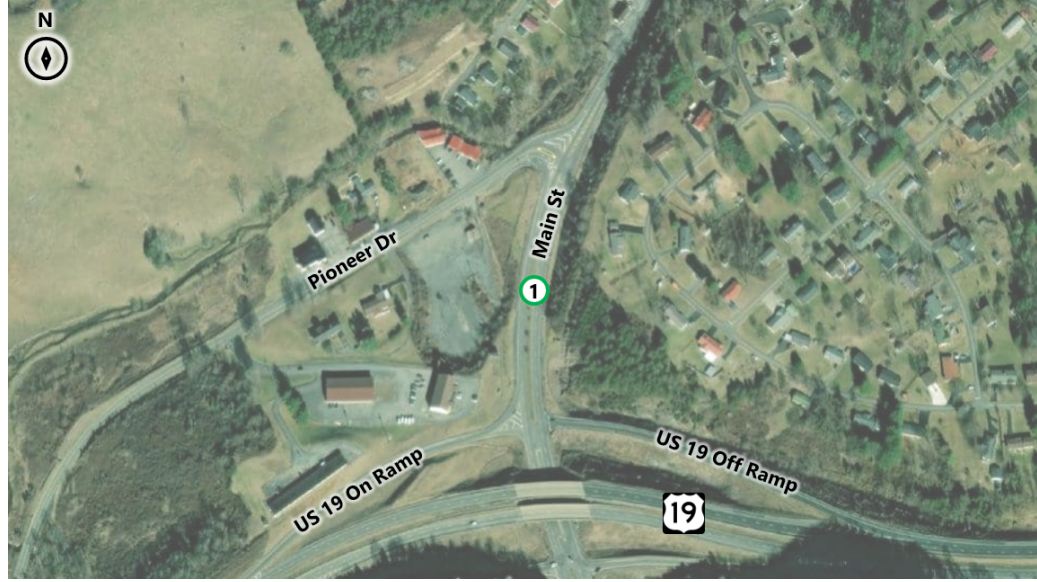
Proposed Solutions to Evaluate in Phase 2

- 1 Restripe Main Street to remove lane drop from functional area of intersection

Note: this safety improvement will be developed with a goal of being implemented during the next repaving schedule. The existing conditions data does not appear to support the funding viability of a larger capital improvement project at this location.

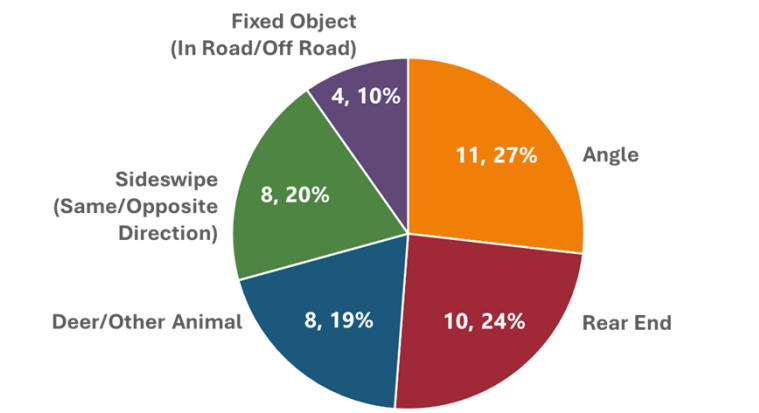
Safety Needs

- Study Area:**
- Segment east of signal is medium (northbound US 19) and low (southbound US 19) priority need for Construction District Safety Improvement
 - 41 crashes (2020-2024)
 - 32% of crashes (13 crashes) involved a distracted driver
 - 20% of crashes (8 crashes) involved a deer/animal and all occurred on US 19 Bypass
 - 27% of crashes (11 crashes) resulted in a fatality or injury
- US 19 Bypass & Regional Park Road:**
- Identified as one of the highest Potential for Safety Improvement (PSI) intersections in Bristol District; PSI rank 10
 - 68% of crashes (23 crashes) occurred at the intersection
 - 29% of intersection crashes (8 crashes) were an angle collision; 1 fatal injury (K) crash due to illegal left turn resulting in 3 fatalities
 - 6 red light running crashes, all angle collisions

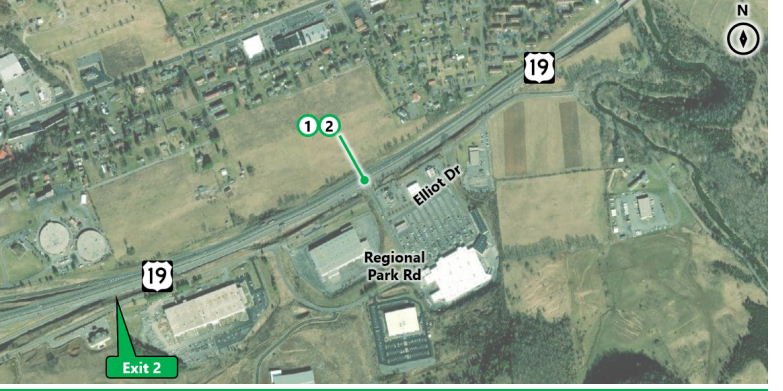
Proposed Solutions to Evaluate in Phase 2

- #### Safety Improvements
- ① Dynamic All Red Extension (DARE) for traffic signal
 - ② Supplemental traffic signal heads not located in the horizon line

Note: these safety improvements will be developed with a goal of submitting for Virginia's Highway Safety Improvement Program (VHSIP) funding. The predominant needs identified at this location – red light running and rear end crashes partially caused by driver behavior and sun glare issues – are best addressed by these types of safety improvement projects.
