Project Overview | BR-23-06

US 11 (Main Street) between Holston Street and Thompson Drive

Phase 1 Conclusion | BR-23-06

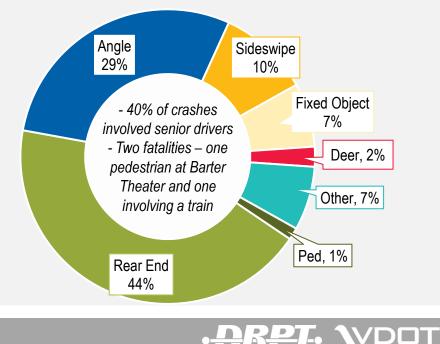
> Study Area Crashes (2018 – 2022 Data) 228 total crashes

/DOT 2018-2022 Crash Data Crashes by Sever		verity			
Hot Spot Intersection / Segment	Α	В	С	0	Total
Holston Street and US 11	0	1	2	10	13
Between Academy Drive and Fuller Street	1	3	1	10	15
Russell Road and US 11	0	3	6	7	16
Between Russell Road and Cummings Street	0	2	4	14	20
Cummings Street and US 11	0	6	3	13	22
Pecan Street and US 11	0	3	1	11	15
Court Street and US 11	0	5	1	15	21
Deadmore Street and US 11	0	0	3	7	10
Trigg Street and US 11	1	1	2	11	15
Thompson Street and US 11	0	2	7	16	25
Total	2	26	30	114	172

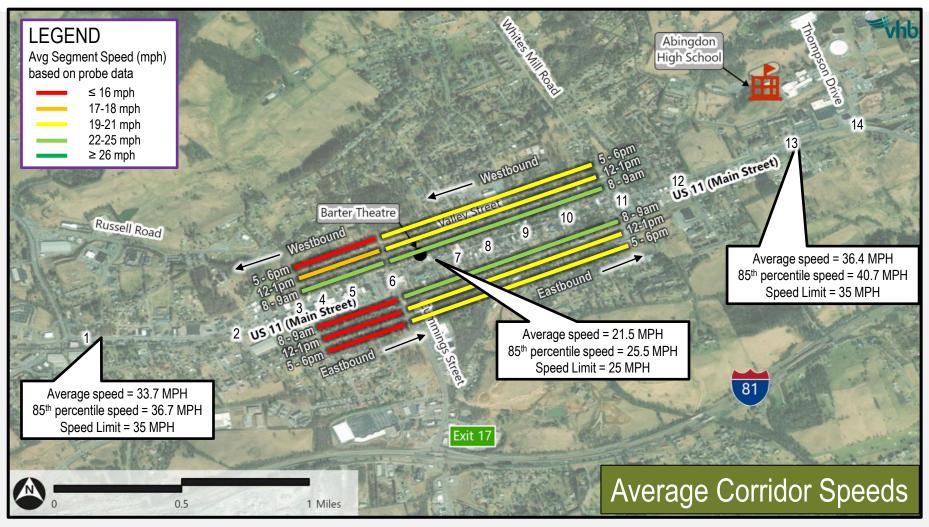
Needs Identification Summary

Operations Summary

- Most intersections perform at an acceptable level of service (LOS). The intersection of US 11 and Cummings Street experiences the most delay of the signalized intersections along the corridor.
- Numerous access points, on-street curb activity (parking and loading), and pedestrian activity contribute to average speeds lower than the speed limit.

Existing Conditions – Synchro Output Intersection Porterfield Highway and US 11* 1. Holston Street and US 11 2. Preston Street and US 11** Fuller Street and US 11** Russell Road and US 11 5. Wall Steet and US 11 6. Cummings Street and US 11 Church Street and US 11** Pecan Street and US 11 9. Court Street and US 11** 10. Tanner Street and US 11** 11. Deadmore Street and US 11** 12. Trigg Street and US 11 13. Bank Street / Boone Street and US 11** 14. Thompson Drive and US 11 Hillman Highway and US 11* Russell Road and Valley Street* Cummings Street and Valley Street* Church Street and Valley Street*,** Court Street and Valley Street* study area.

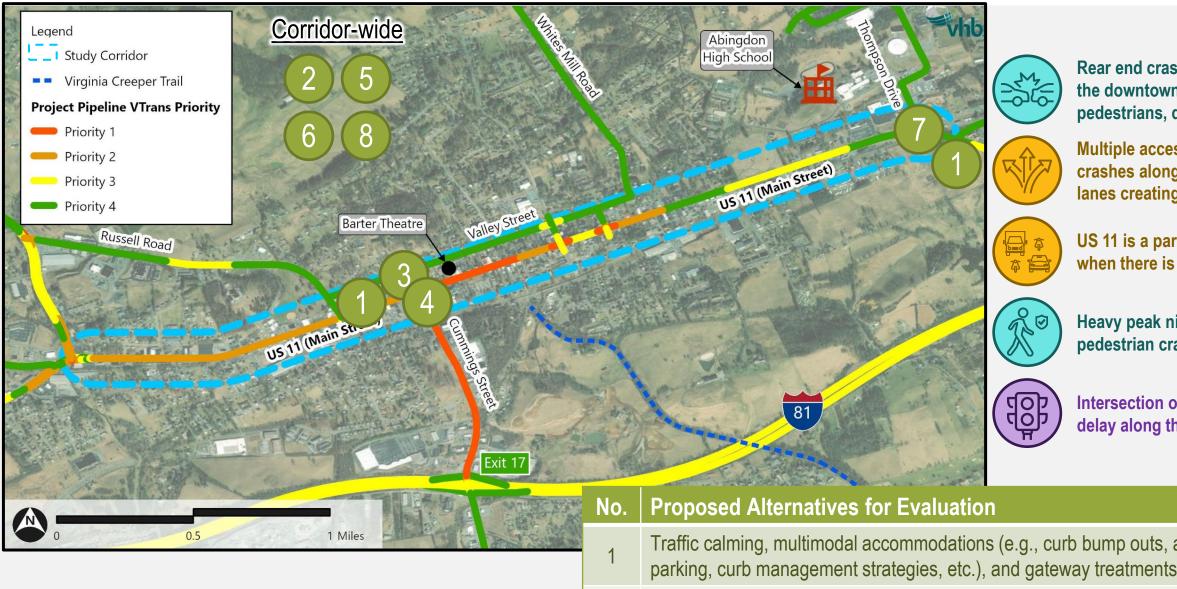
- 2 Corridor-wide access management strategies
- 3 Quadrant intersection at Cummings Street
- 4 Turn lane reconfiguration at Cummings Street
- 5 Corridor-wide pedestrian improvements
- 6 Low-cost safety treatments
- 7 Alternative connection to Baugh Lane
- 8 Transit enhancements (stop amenities, microtransit viability)
