Project Overview | BR-23-08

US 58 (Bristol Highway) between Wadlow Gap Highway and AP Carter Highway

Phase 1 Conclusion | BR-23-08

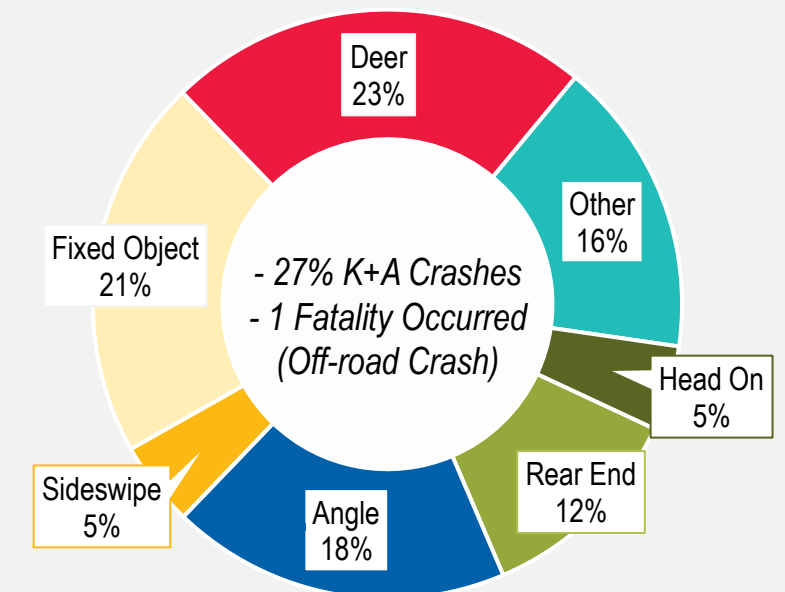
Study Area Crashes (2018 – 2022 Data)
33 total crashes

- Pattern of angle crashes at the intersection of US 58 and Wadlow Gap Highway involving westbound and northbound vehicles. Contributing factors include the speed of northbound vehicles and confusion regarding northbound lane usage.
- 10 Deer crashes were reported throughout the study corridor between 2018-2022.
- Fixed-object crashes primarily occurred at night in horizontal curve locations. Contributing factors include lack of curve warning signs, narrow shoulders, and lack of rumble strips.
